The (Un)interruptible Power Supply

Loss of 400 kV supply and subsequent failure to start emergency diesel-generators in trains A and B at the Forsmark 1 unit on 25 July 2006

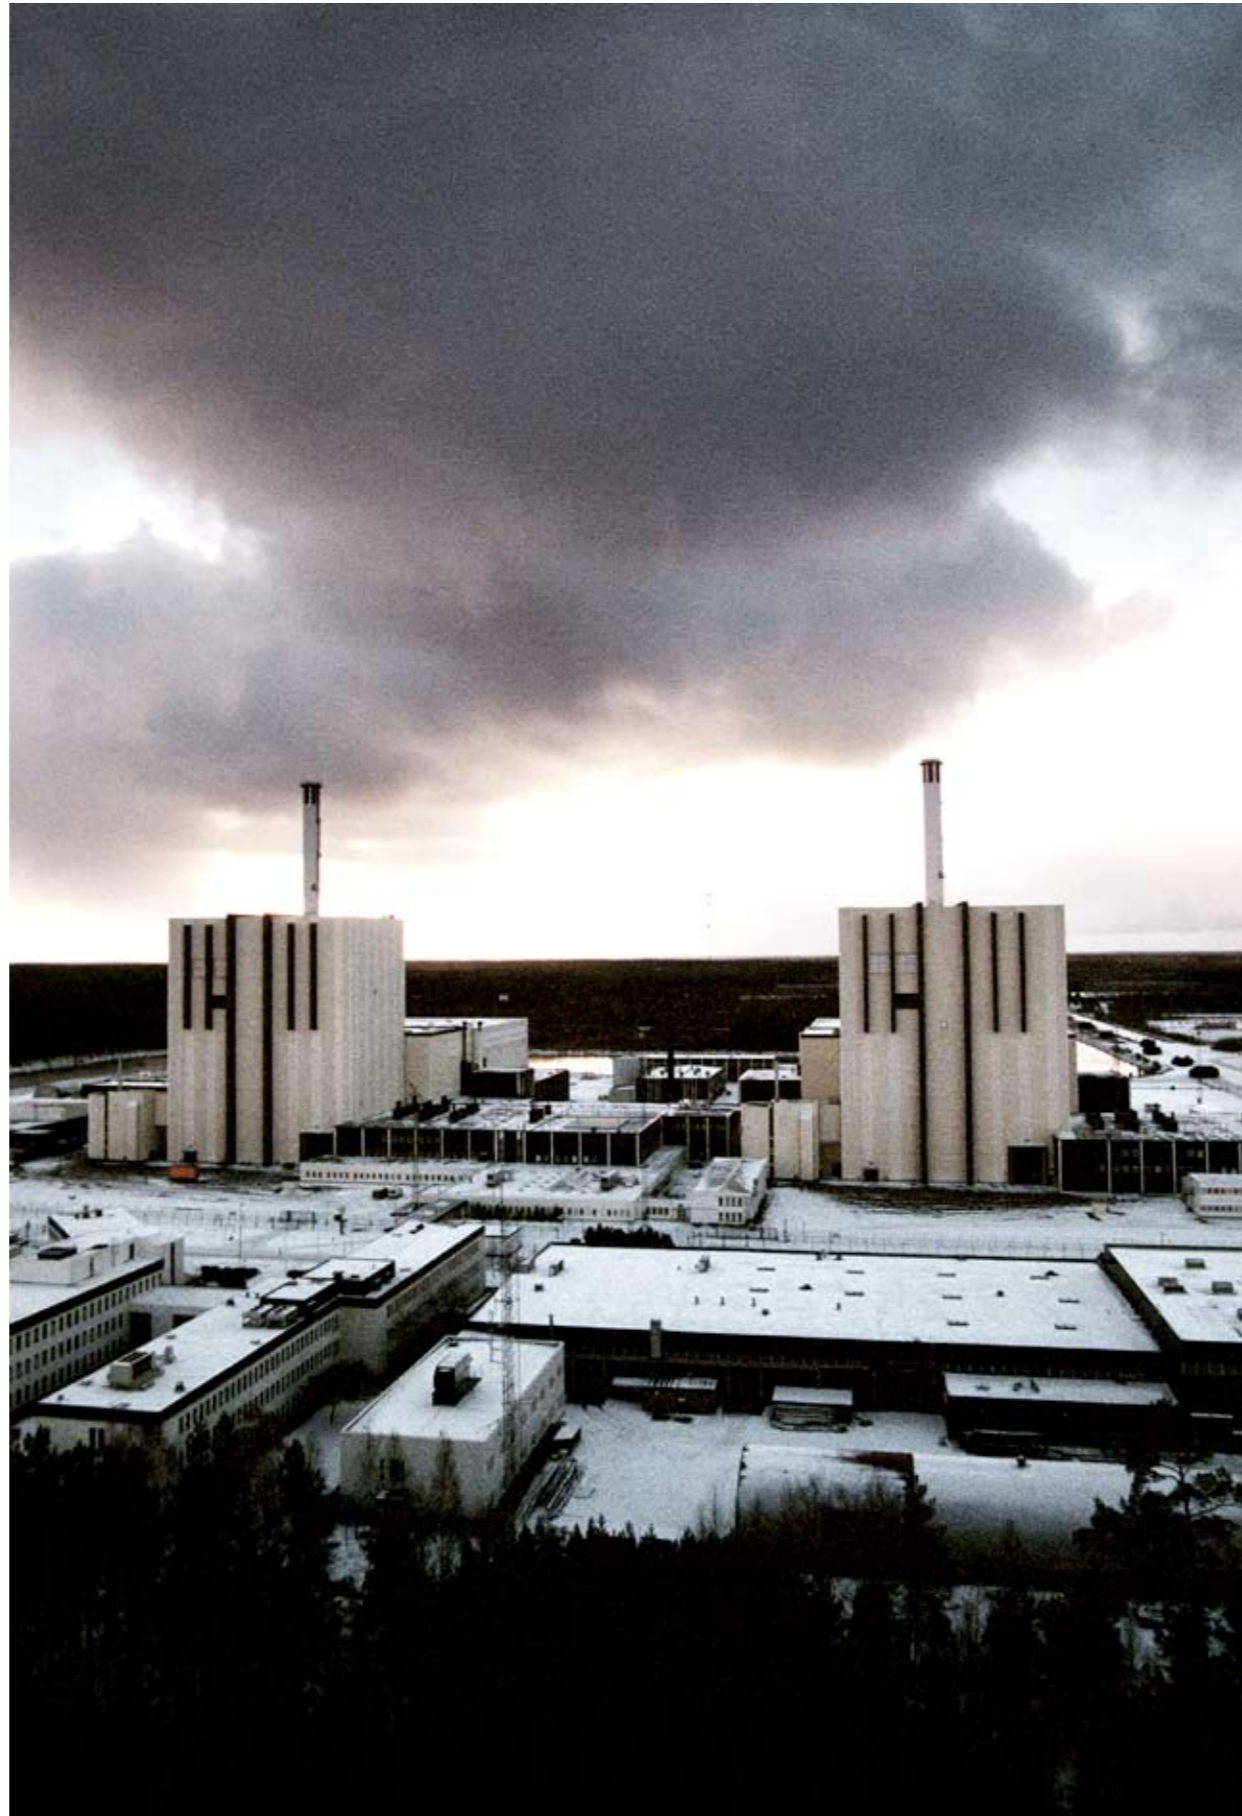
The initial over-voltage resulted in the loss of the UPS in trains A and B within two (2) seconds. This was due to the activation of the DC voltage safeguard on over-voltage on both the rectifiers and the inverters in these UPS units. These activation limits were set according to the values recommended by the designers and accepted by the Licensee. The safeguard for the components functioned, although with inadequate selectivity. Had only the rectifiers been isolated and hence protecting the inverters, then the batteries would have been able to provide power to the bus-bars via the inverters, as expected. Thus component safeguard compromised the safety of the plant.

Tests made at the manufacturer's premises with the original safeguard settings show that the over-voltage protection for the UPS inverters functions as expected for voltages between 85% and 110% of nominal. The actual voltage transient at Forsmark 1 lay outside this band and the UPS units were disabled. The Licensee and the manufacturer have made exhaustive analyses to find the reasons for the UPS in trains C and D remaining operational. The conclusion drawn is that the AC voltage protection of the rectifiers in these units was activated by the under-voltage, and the inverters were then unaffected by the isolation of the rectifiers. Automatic restart of the UPS units took place when the voltage surge had decayed.

The transient over-voltage propagated down through the transformers of the electrical systems of the unit and tripped the rectifiers and inverters on the battery-supported 220 V AC grid of the uninterruptible power supply (UPS) trains A and B. This voltage transient did not, however, affect trains C and D.
